RCRA Enforcement Inspection

Bayonne Barrel and Drum  
Newark, New Jersey

NJD009871401

June 2, 1988

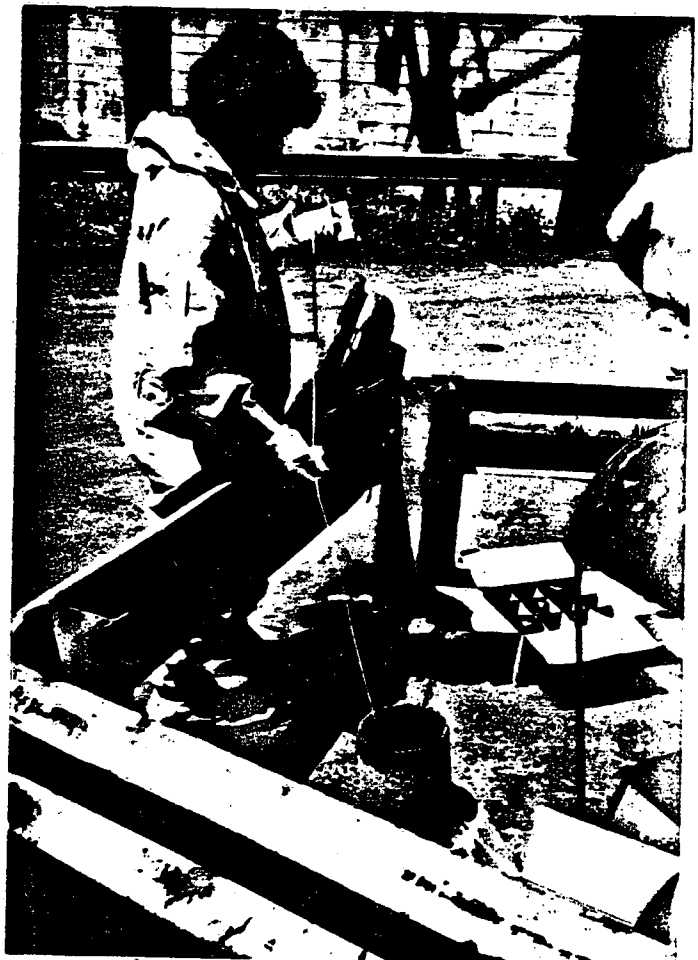
#2. Underground tank, item #7  
on attached site map.  
Measuring total depth of  
tank.

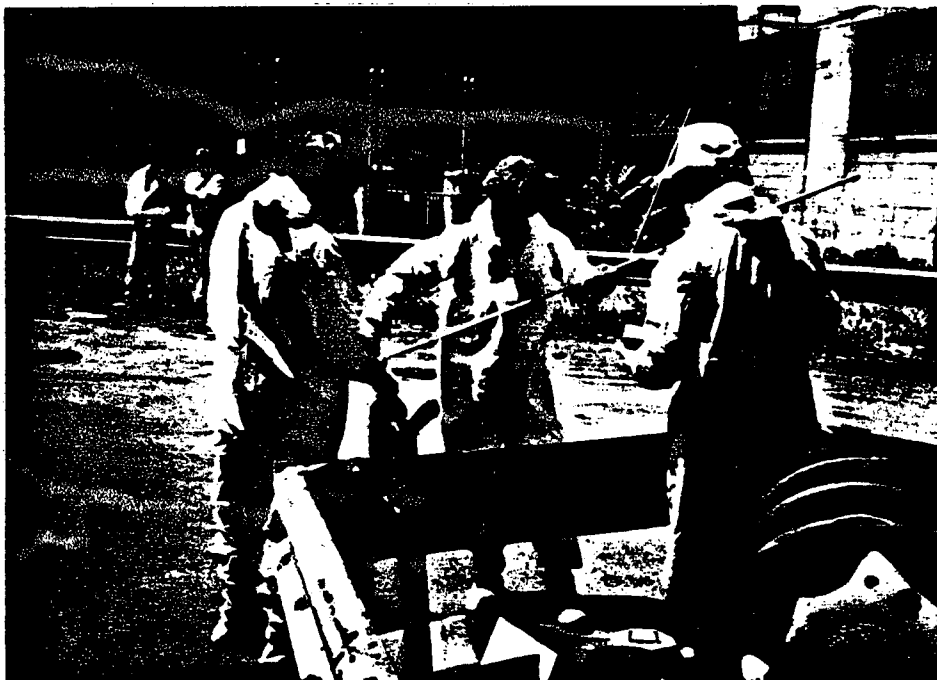
#3. Sampling underground tank.

Sample #112207 - Aqueous samples were collected from an underground tank near the toluene pump. The sample was collected by taping an I-Chem Series 300 glass jar to an aluminum rod. The sample was collected in this manner due to the size of the access standpipe. In addition, the aluminum rod was shaped to fit the angled opening of the tank. See picture #3, which illustrates sampling of the underground tank.

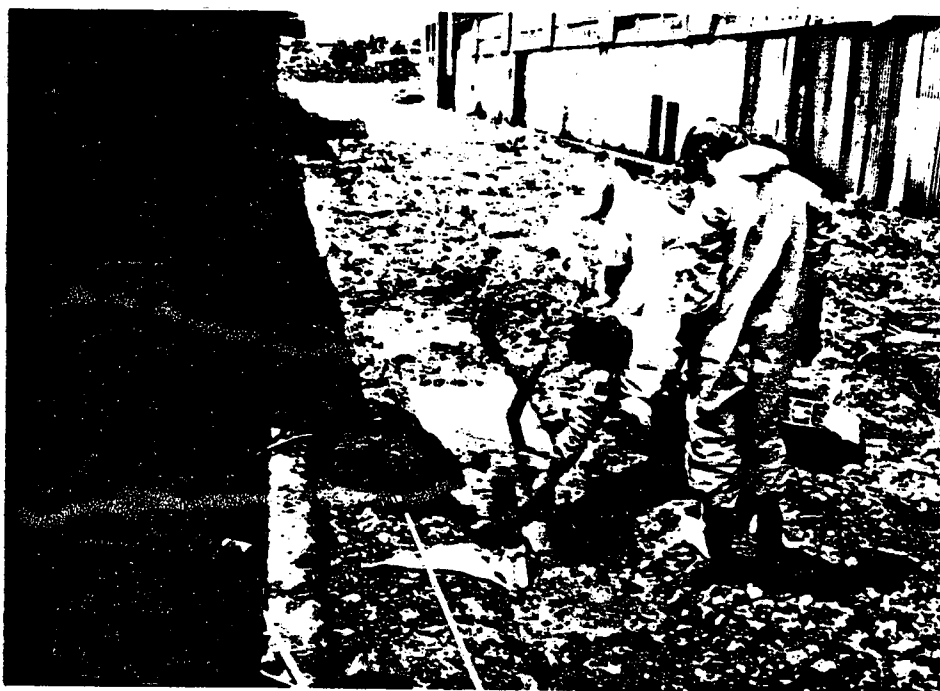
#4. Collection of aqueous samples from courtyard area. Item #2 on attached site map.

Sample #112208 - In addition to collecting ash samples from the courtyard, aqueous samples were also collected as depicted in photograph #4. Ponded water samples were collected in a low lying area adjacent to the courtyard ash pile and incinerator. Sample collection technique was by direct filling an I-Chem Series 300 glass jar and pouring into the appropriate sample containers.

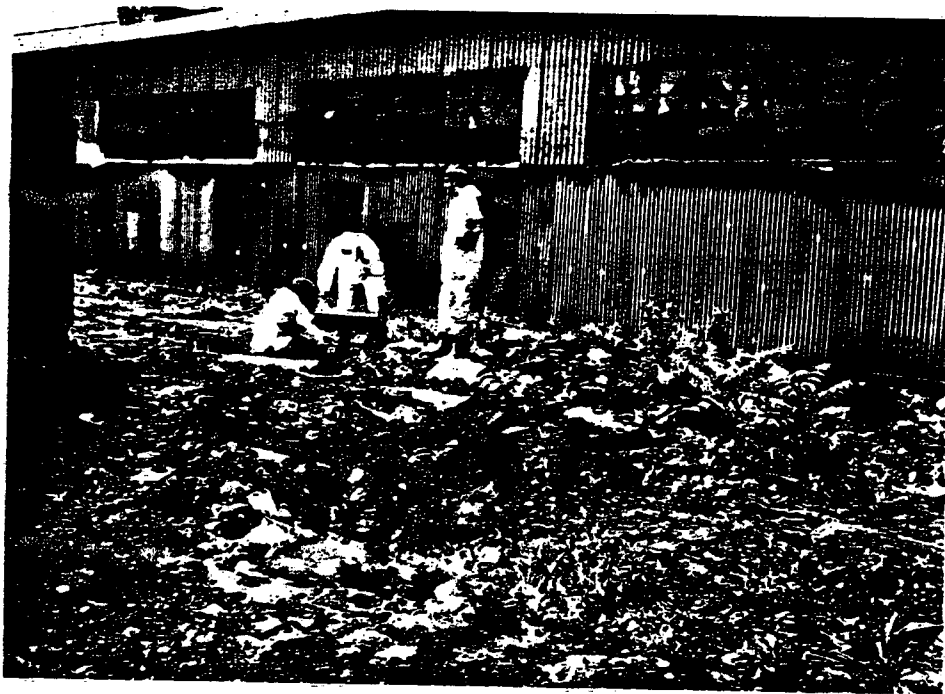
#5. Collection of random, grab composite ash sample from courtyard area.

Sample #112202 - Courtyard area ash sample collected at random using the same techniques as listed in sample #112201. Photographs #5 - 9 illustrate the sample location and collection techniques. Make special notice of the various colors encountered in the ash pile and sample collected.

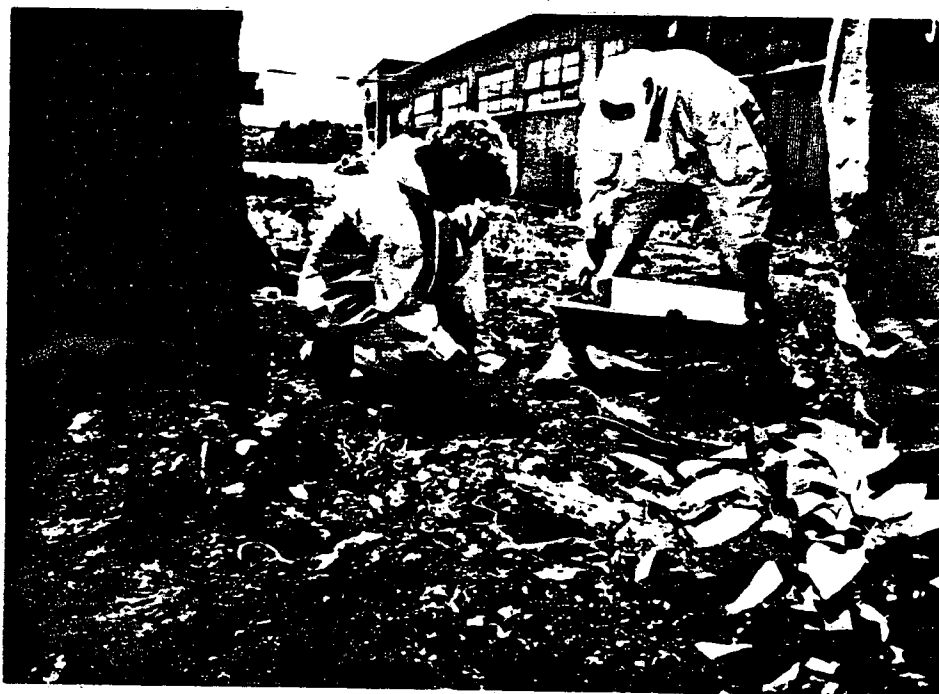
#6. Close-up of ash pile in courtyard, similar to photo #5.

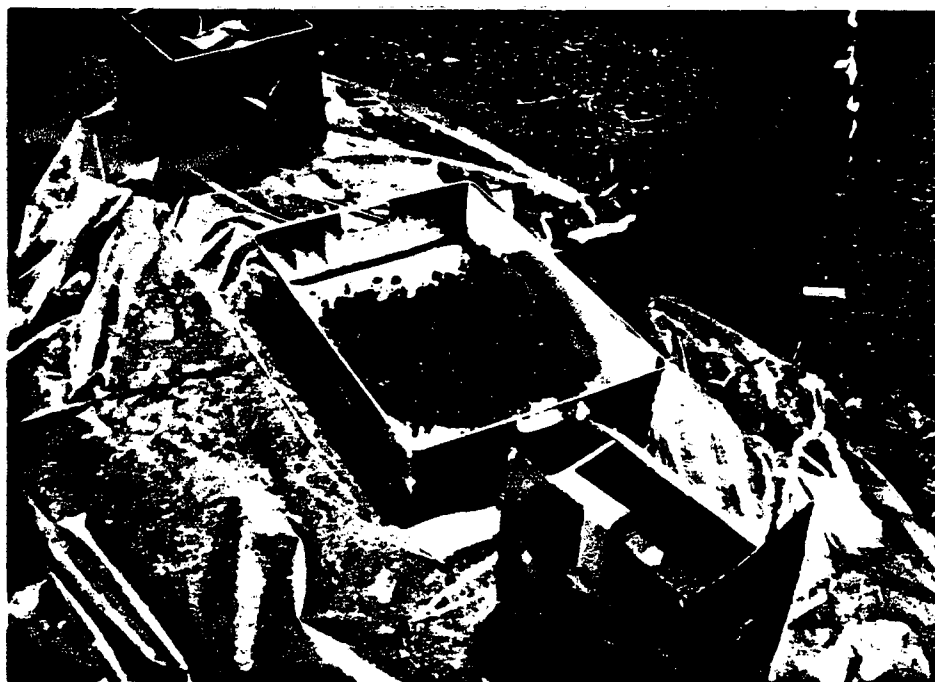
#7. Ash from courtyard area ash pile, ready for compositing.

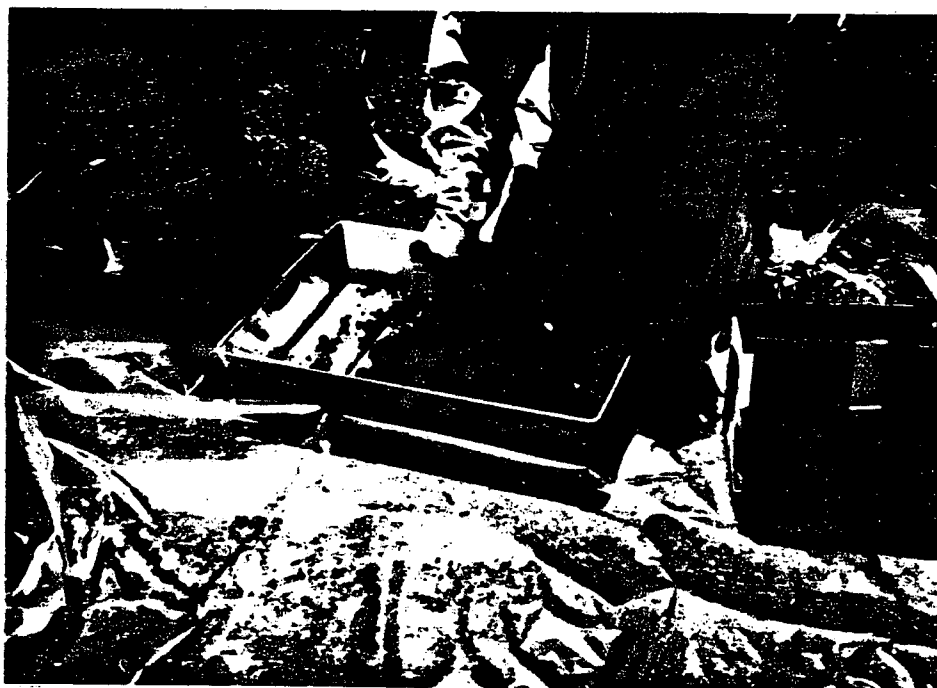
#8. Compositing ash sample from courtyard area, prior to filling sample containers.

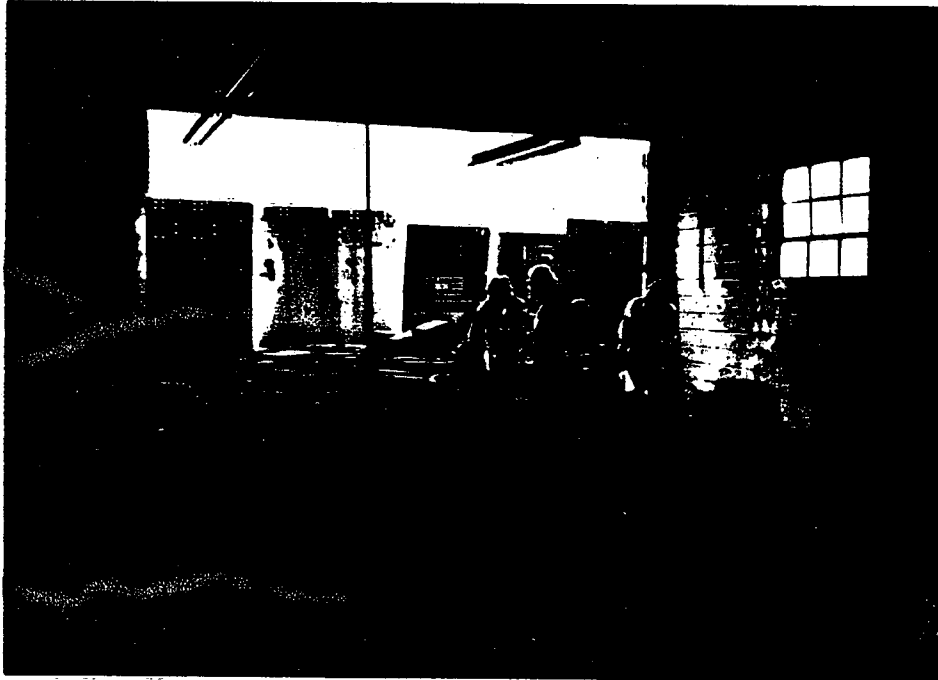
Sample #112213 - An aqueous sample was collected from a "RED" drum in the drum and ash storage room as depicted in photographs #11 - 12. Level B PPE was worn due to the presence of high concentrations of unknown organic contaminants. The drum was sampled using a precleaned, dedicated teflon bailer. Pictures #13 - 14 indicate the particular red drum which was sampled and other drums in the immediate area. Note the condition of the drums in all four photographs. Most of the drums contained ash which looked similar in nature to the ash pile in the center of the room. However, some of the drums contained liquids of unknown content. Many of the containers were in very poor condition, some with holes and a few inverted to prevent their contents from leaking onto the floor.

#11. Sampling "red" drum in the drum and ash storage room; item #3 on the attached site map.

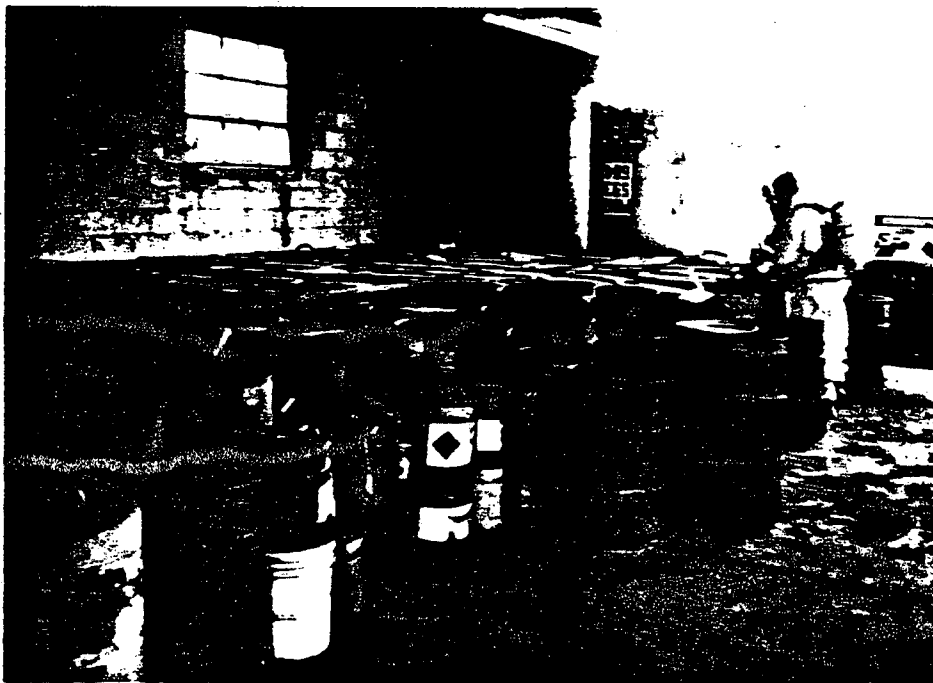
The drum and ash storage room contained many drums, approximately 100-150, which were not marked as a hazardous waste and were apparently stored in excess of 90 days.

#12. Overview of some of the many drums in the drum and ash storage room. Note condition of drums and old labels.

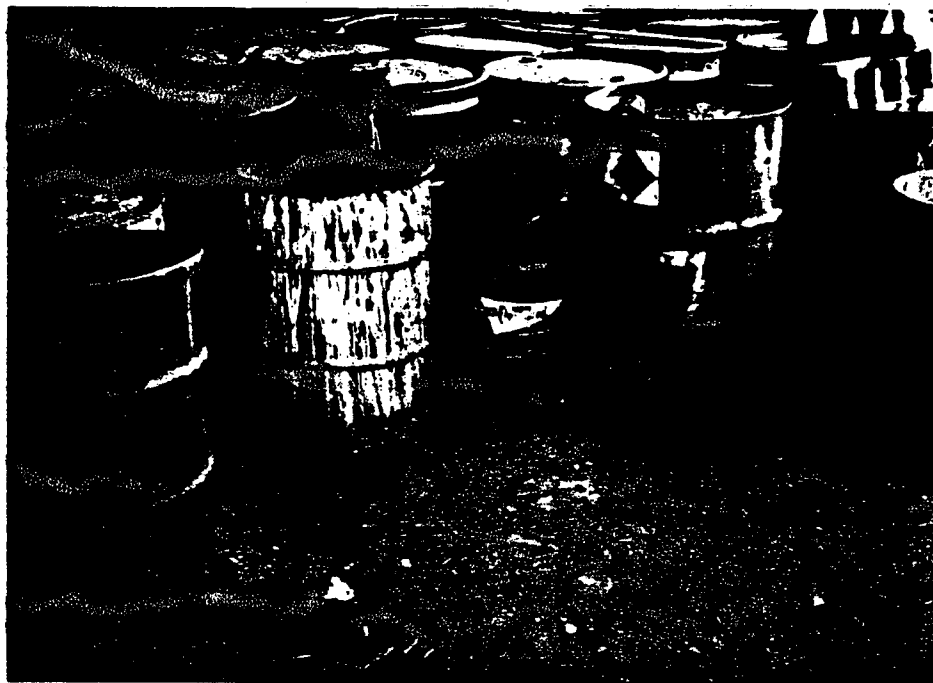
#13. "Red" drum which was sampled in the drum and ash storage room.

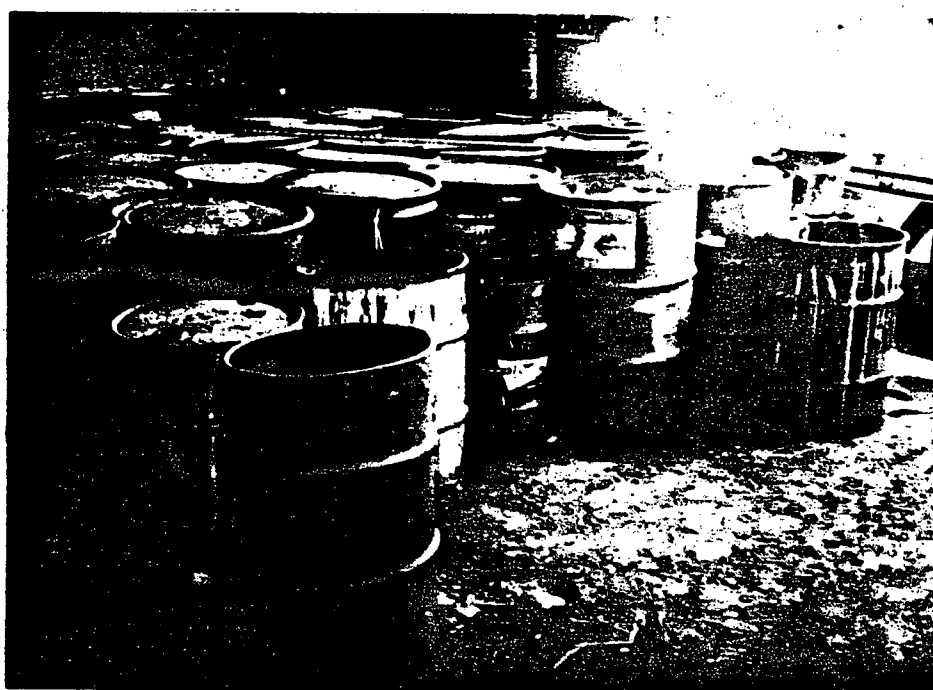
#14. Another view of drums in the drum and ash storage room.

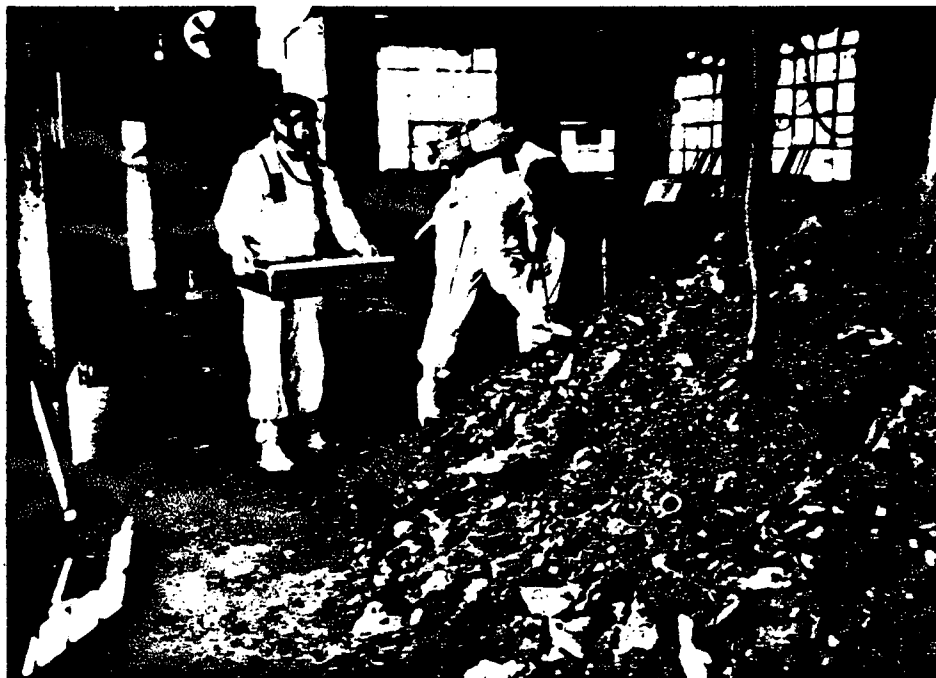
Sample #112203 - Drum and Ash storage room ash sample collected in a manner identical to that listed in sample #112201. Level B personal protective equipment (PPE) was worn in this area due to the presence of hazardous organic vapors, as indicated by air monitoring equipment. Pictures #15-16 illustrate sampling technique and level of protective equipment required.

#15. Sampling the ash pile in the drum and ash storage room. Note presence of drums in background.

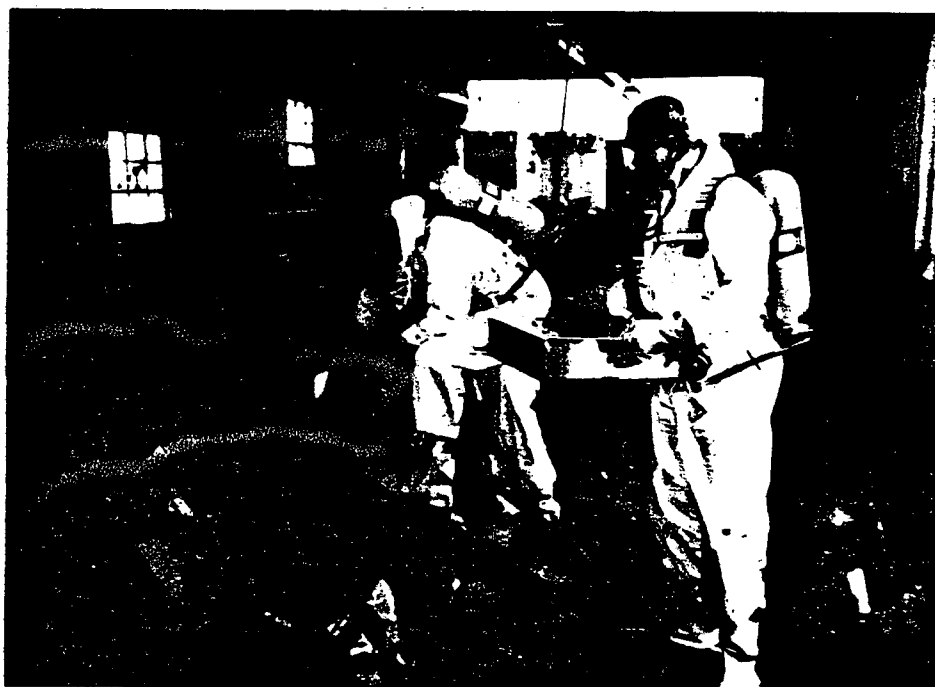
#16. Opposite view of ash pile in drum and ash storage room.

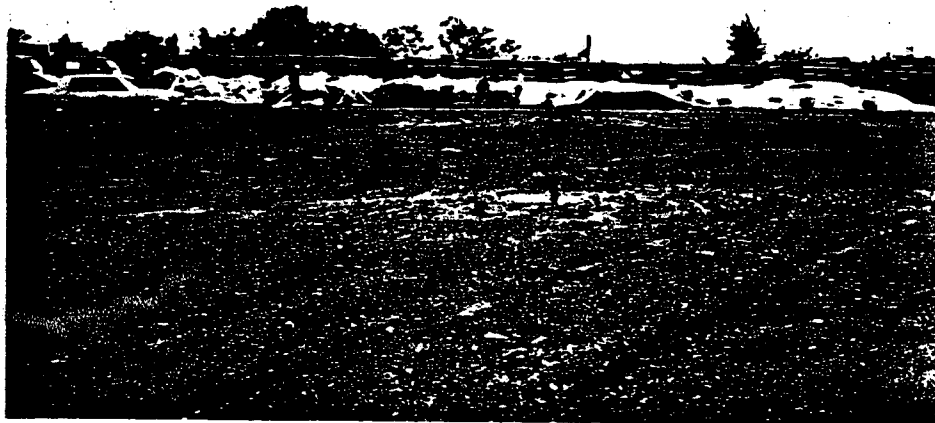
The waste ash pile was still in violation of 40 CFR Part 265, Subpart L (waste piles) during the initial site visit on May 12, 1988. The pile was subsequently covered by sheet plastic on May 19, 1988. However, a containment system to prevent and collect run-off or eliminate a discharge to groundwater does not exist.

- #17. Waste ash pile, item #4 on the attached site map. An imaginary line was drawn through the ash pile to delineate an EAST and WEST half.

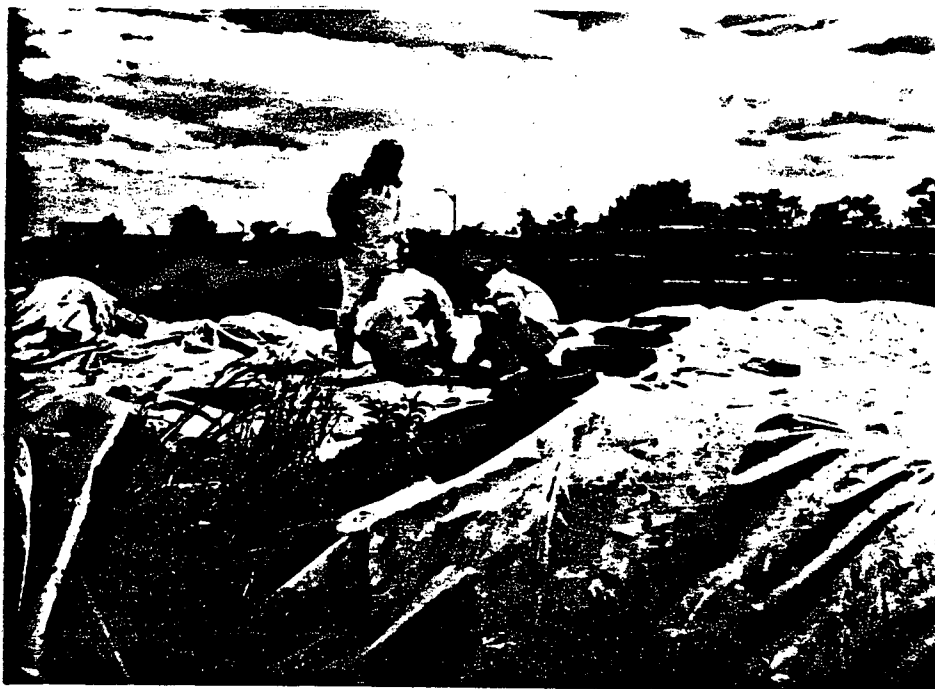
Sample #112212 - This sample number represents the "EAST" half of the waste ash pile near the drum storage area. Photograph #18 depicts sampling the "EAST" half of the ash pile while wearing Level C PPE. Sample collection techniques were the same as in sample #112204. A series of random grab samples were collected using a dedicated polypropylene scoop and then composited in a stainless steel tray. After the sample was thoroughly mixed, the respective sample containers were filled.

- #18. Sampling East half of the ash pile. Samples were collected at random and manually composited in a stainless steel tray.

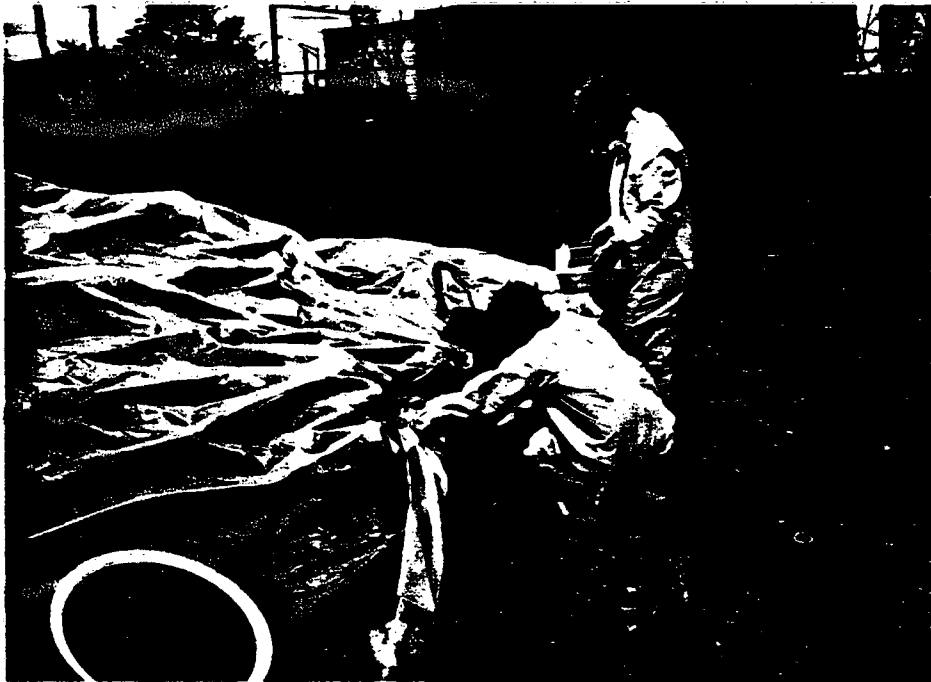
Sample #112204 - This sample number represents the "WEST" half of the waste ash pile near the drum storage area. An imaginary line was drawn through the ash pile to delineate an "EAST" and "WEST" half, for the purpose of sampling only. Figure 1 shows the relative location of the ash pile and illustrates the approximate boundary drawn to delineate the two halves. Photographs #17 and 19 illustrate the entire waste ash pile and sample collection in the "WEST" half, respectively. Level C PPE was worn during sample collection and compositing. Since the ash pile was covered with polyethylene plastic sheeting, holes were cut at random to enable sample collection. Samples were collected using a dedicated polypropylene scoop and thoroughly mixed in a stainless steel tray to form a composite sample.

#19. Sampling West half of ash pile; item #4  
on the attached site map.
